# Manhole Inspection Summary

Manhole # S47G2\_013MH

Insp Date: **1/28/08 7:56 AM**

**Location** Address: **4501 Curtis Ave**

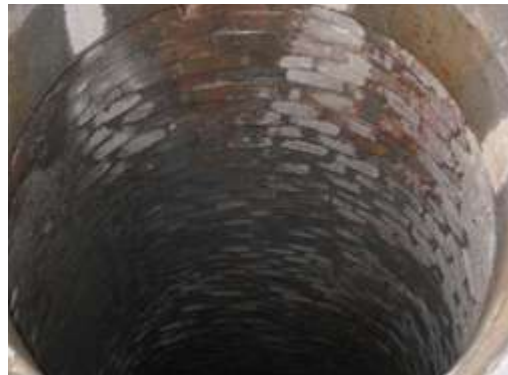
Defect 1

Infiltration: ☐ None ☐ Joint ☐ Cracks ☐ Mortar ☐ Roots ☒ Wall

wall

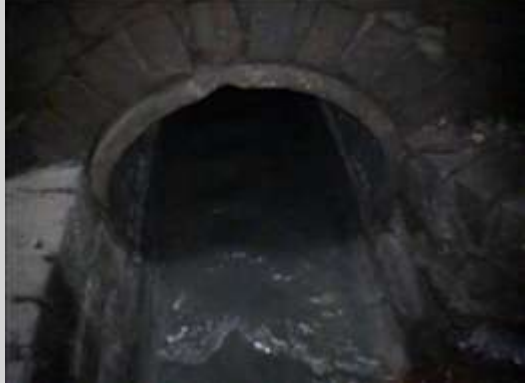
12 O'Clock Outflow

18 in. Circular Gravity Sewer  
Pipe Out @ 12 O'Clock

Pipe Height: **20.4** (in.) Rod and Bar (Angled)  
Pipe Material: **Clay** ☐ Pipe Lined  
Invert Depth: **16.96** (ft.) Flow Characteristics: **Fast**  
Deposits: ☒ None ☐ Mud ☐ Sludge ☐ Debris ☐ Grease  
Silt Depth: (in.) Deposits Extent:  
Infiltration: **None** Pipe Seal Cond: **Sound**

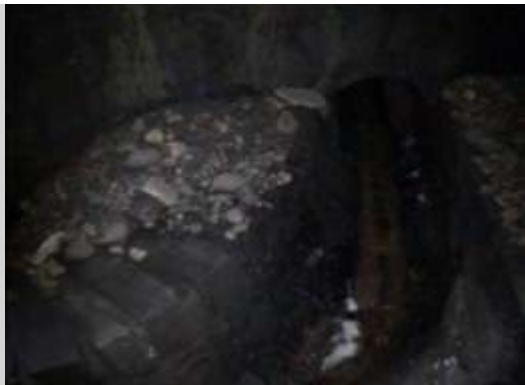
3 O'Clock Inflow

8 in. Circular Service Sewer  
Pipe In @ 3 O'Clock

Pipe Height: **8.4** (in.) Rod and Bar (Angled)  
Pipe Material: **Clay** ☐ Pipe Lined  
Invert Depth: **16.44** (ft.) Flow Characteristics: **None**  
Deposits: ☒ None ☐ Mud ☐ Sludge ☐ Debris ☐ Grease  
Silt Depth: (in.) Deposits Extent:  
Infiltration: **None** Pipe Seal Cond: **Sound**

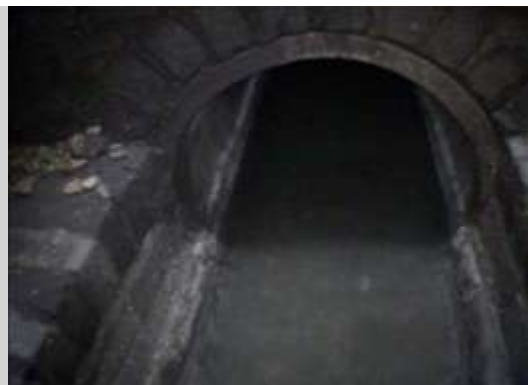
6 O'Clock Inflow

18 in. Circular Gravity Sewer  
Pipe In @ 6 O'Clock

Pipe Height: **20.4** (in.) Rod and Bar (Angled)

Infiltration: **None** Pipe Seal Cond: **Sound**
